**CITY OF LOS ANGELES
DEPARTMENT OF PUBLIC WORKS
LA SANITATION AND ENVIRONMENT**

**30-DAY REPORT
ON
UNPLANNED DISCHARGE TO 1-MILE OUTFALL OF
UNTREATED WASTEWATER ON JULY 11 AND 12, 2021**

**HYPERION TREATMENT PLANT
12000 VISTA DEL MAR, PLAYA DEL REY, CALIFORNIA
(NPDES PERMIT NO. CA0109991, ORDER NO. R4-2017-0045)**

AUGUST 13, 2021

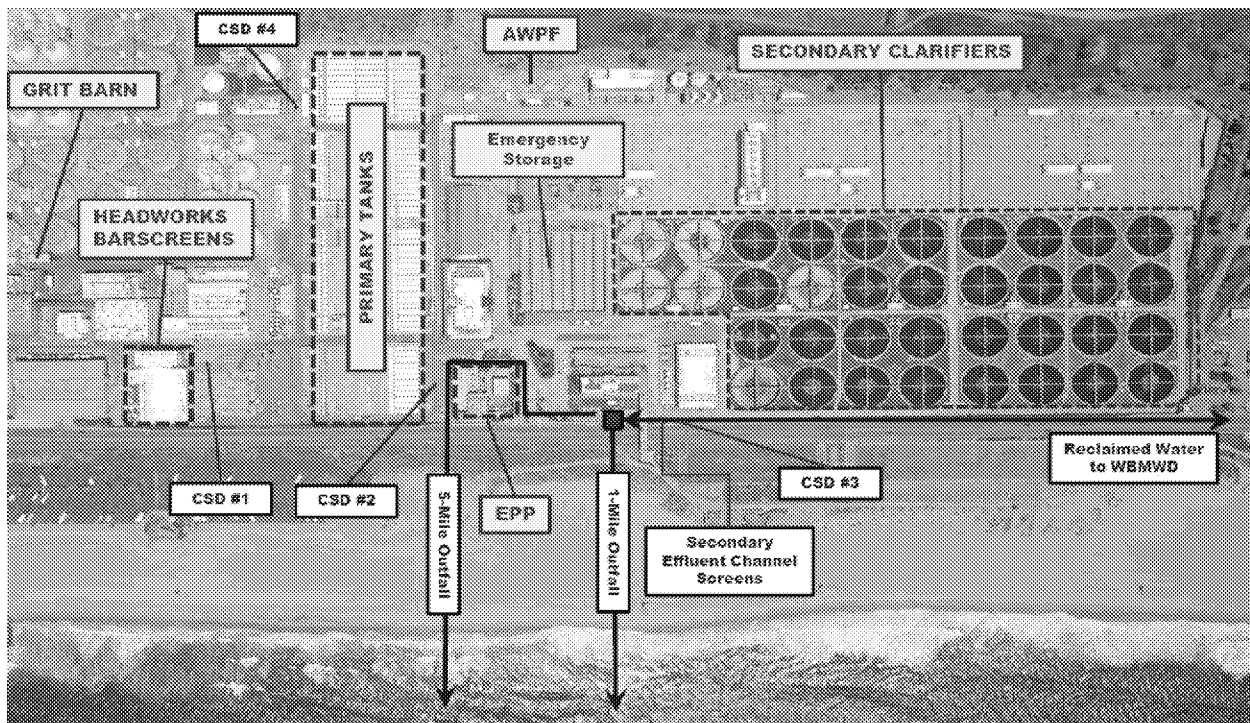
Figure 3 – Hyperion Preliminary, Primary, and Secondary Treatment Processes

The plant treatment processes are very effective in removing trash and debris. The trash and debris removal process in Hyperion takes place at the following steps of the treatment process as shown in Figure 3:

- STEP 1 - HEADWORKS BARSCREEN
- STEP 2 - PRIMARY TANK SKIMMERS
- STEP 3 - SECONDARY CLARIFIER SKIMMERS

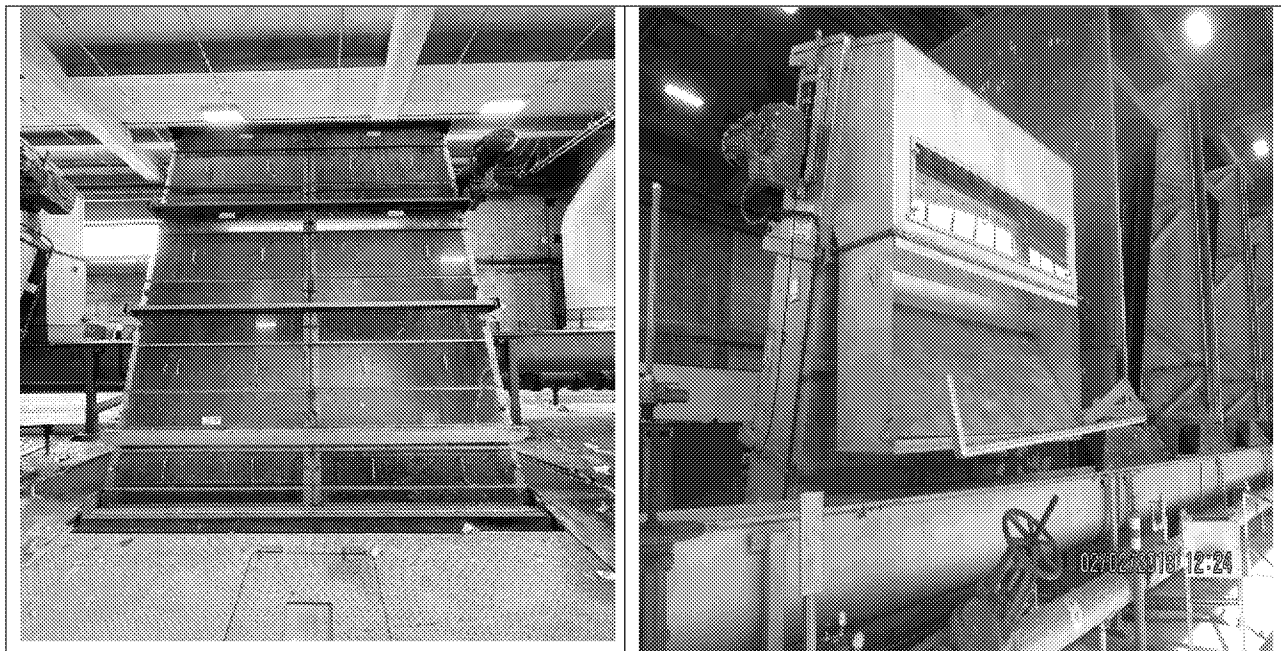
Figure 4 – Hyperion Mechanically-Raked Barscreens Installed in June 2019

In the event of a blockage on the barscreen that causes an overload condition, the rake mechanism can automatically reverse direction for a predetermined distance and then resume traveling in its original direction in an attempt to clear the blockage. This motion is repeated a maximum of three times in attempting to clear the blockage. The process of clearing the blockage will be either set at normal speed or high speed, ten second interval or five second interval, respectively.

If the blockage is cleared, the barscreen will reset automatically. If the attempts fail to clear the blockage, the barscreen will trip and set off an alarm.

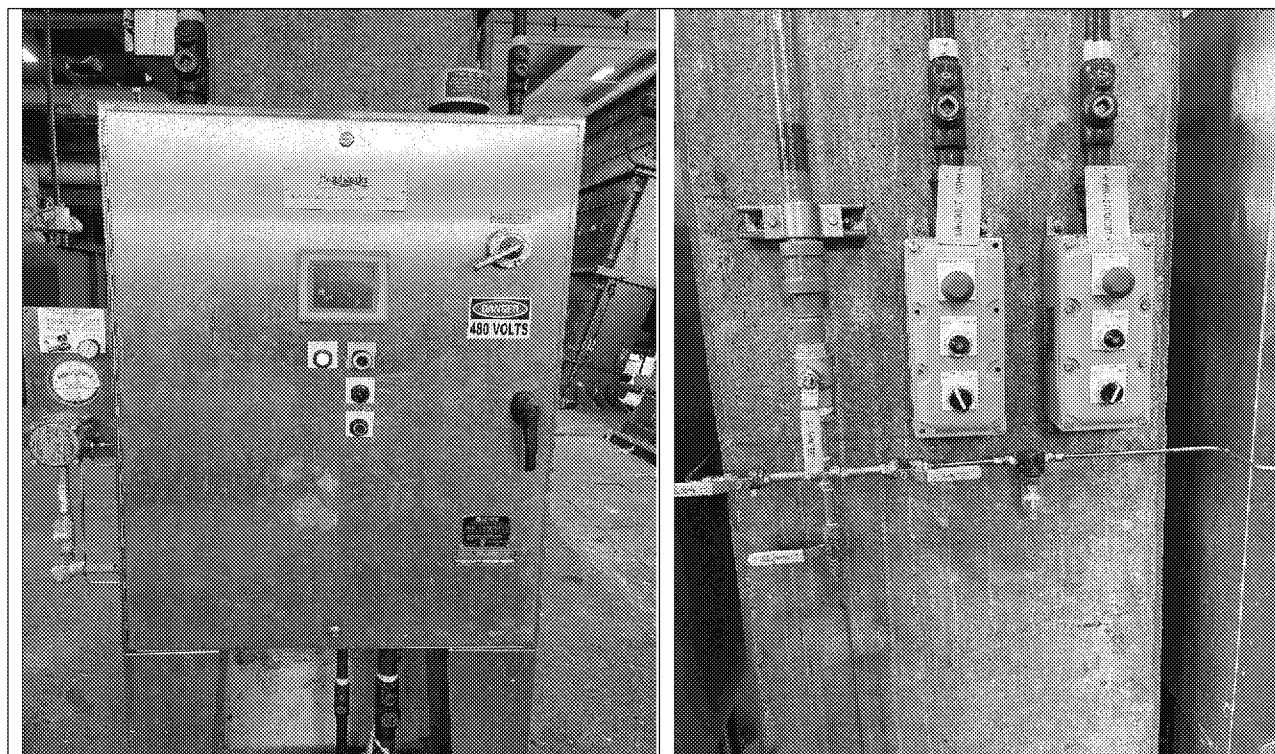
Figure 5 –Barscreen Controls

Each barscreen is equipped with Allen Bradley PanelView Plus 600 Operator Interface Terminal (OIT) to allow push button adjustment of counter values, timers and level set points. The barscreen can be set up with upstream and downstream level sensors for automatic on/off operation based on the levels. However, when the barscreens were installed in 2019, Hyperion decided to run the barscreens on manual mode because of risks involved with unreliable level sensors. In manual mode, forward-fast speed, forward-slow speed, reverse rotation can be selected. All the time, operators keep the fast-forward speed for fast raking of the debris collected on the screen. Also there is the unplugging built-in function in the OIT, which reverses the motor rotation when plugging of barscreen is sensed (by high motor torque). When this unplugging function is activated, the motor goes to reverse and forward multiple times before it shuts down. Also, the OIT has the timer, which allows to run the barscreens on the timer.

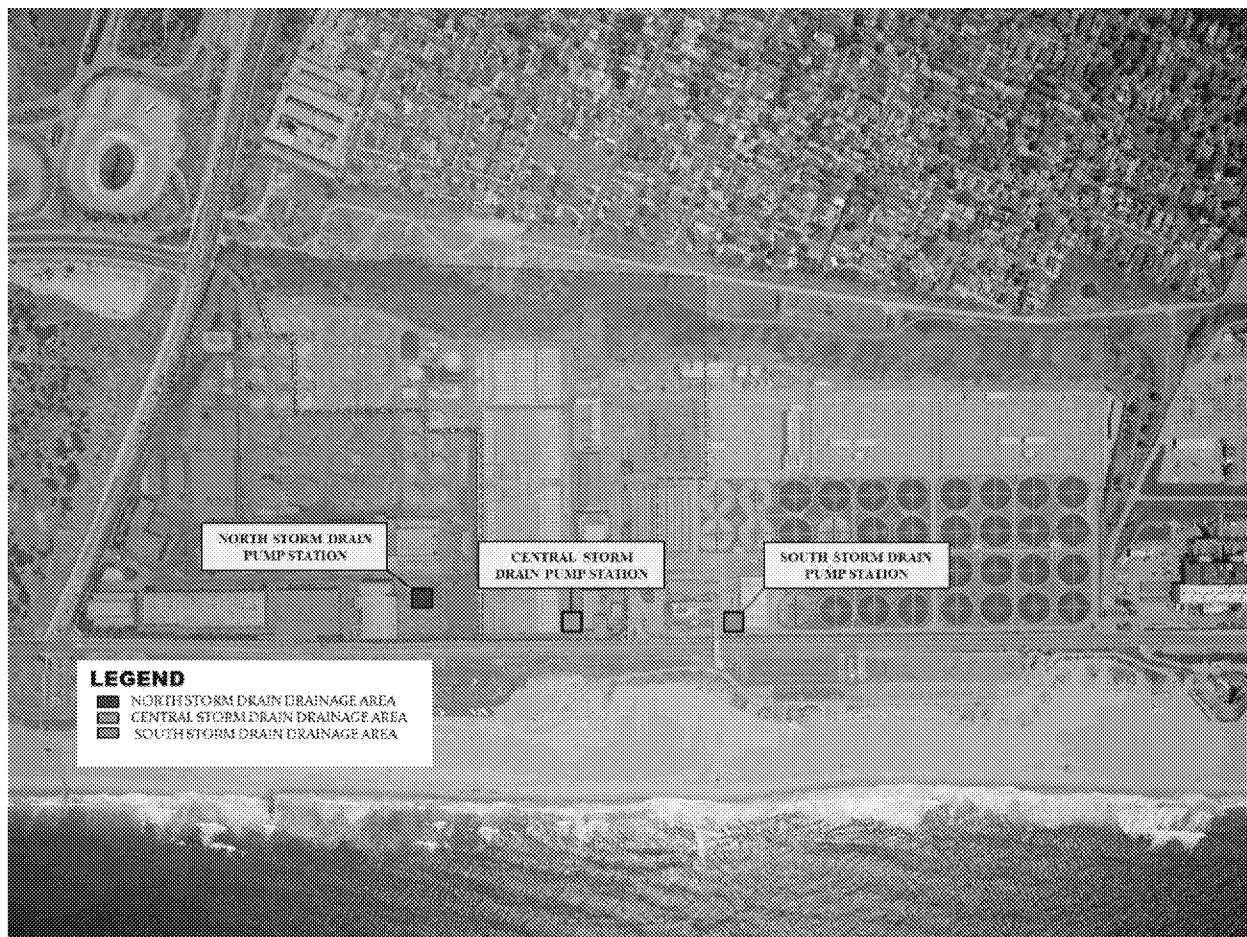
Figure 8 – North, Central, and South Storm Drain Pump Stations Drainage Area

The north area covers 37 acres of drainage area and includes most of the influent and solids handling processes, such as the headworks, digesters, dewatering and biosolids truck loading. Many of these processes are above ground and have a higher potential for spill of untreated wastewater, sludge and chemicals than process areas that are below ground and contained in channels and tanks.

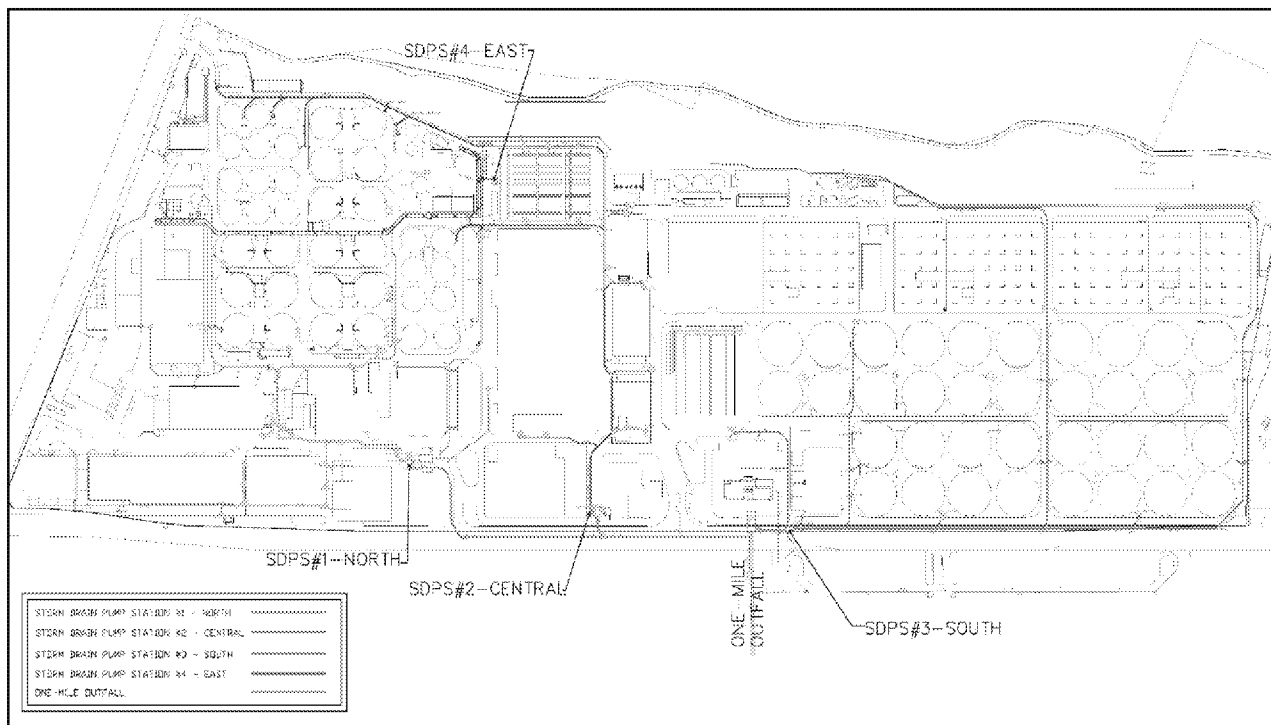
Figure 9 – Storm Water Collection and Overflow to 1-Mile Outfall

Hyperion's storm drain system is designed to collect and process rainfall on the property as well as any chemical, biosolids or untreated wastewater spills from the treatment processes. The plant has three drainage areas: north, central and south (Figures 8 and 9). Each drainage area drains into a storm drain pump station that returns the collected flow to the Headworks to be treated. Flow in excess of the pump station capacity overflows to the 1-Mile Outfall. Figure 9 shows the storm collection network and the overflow piping connections to the 1-Mile Outfall.

The North Storm Drain Pump Station, with a wet-well capacity of 313,000 gallons and three pumps, at 6,000 gallons per minute (gpm) capacity each, is sized to process a storm with an intensity of up to one inch per hour or a large spill. The flow enters the forebay and passes through a 3-inch screen to the wet-well pumps. If the flow exceeds the pump capacity, it will overflow a weir, pass through a 3-inch screen, which was replaced in 2015 with a 3/8-inch screen, and discharge to a 48-inch overflow line that connects to the 1-Mile Outfall outside the plant, in Vista del Mar. Per design, the pumps are controlled locally by float switches, and the pump status can be monitored remotely.

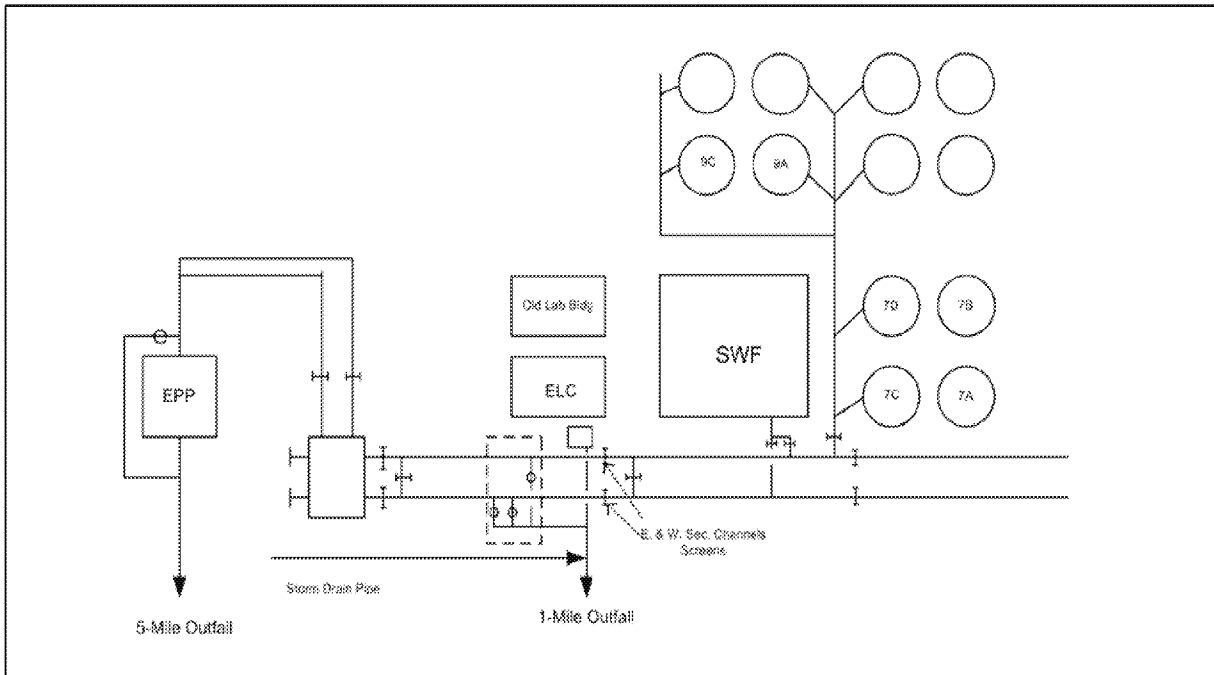
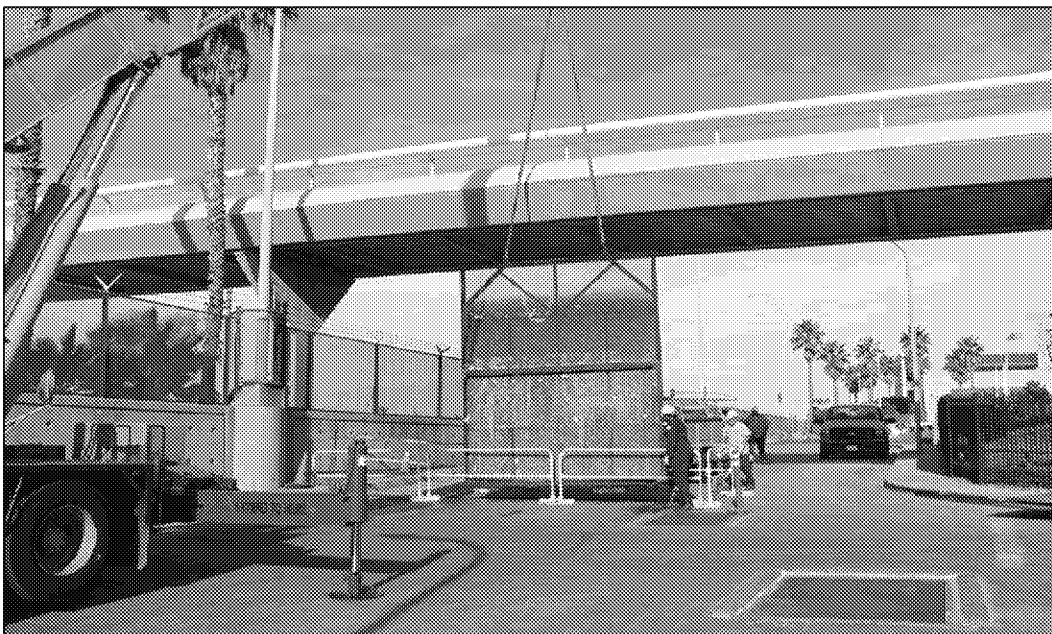
On September 24, 2016, stainless steel screens were installed in existing bulkhead slots in both of the two Hyperion secondary effluent channels to capture any debris before the secondary effluent is discharged into the Santa Monica Bay. The screens provide a fourth line of defense to prevent trash and/or debris from exiting the plant. The screens have 3/8-inch openings (small enough to capture all FHP) and have baskets along the bottom edge to catch any plastics that would dislodge when the screens are pulled out for inspection and cleaning. Hyperion staff clean both channel screens twice per week. Most of debris collected has been stickers only. See Figures 10 to 12 for the location and the cleaning operation of the screens.

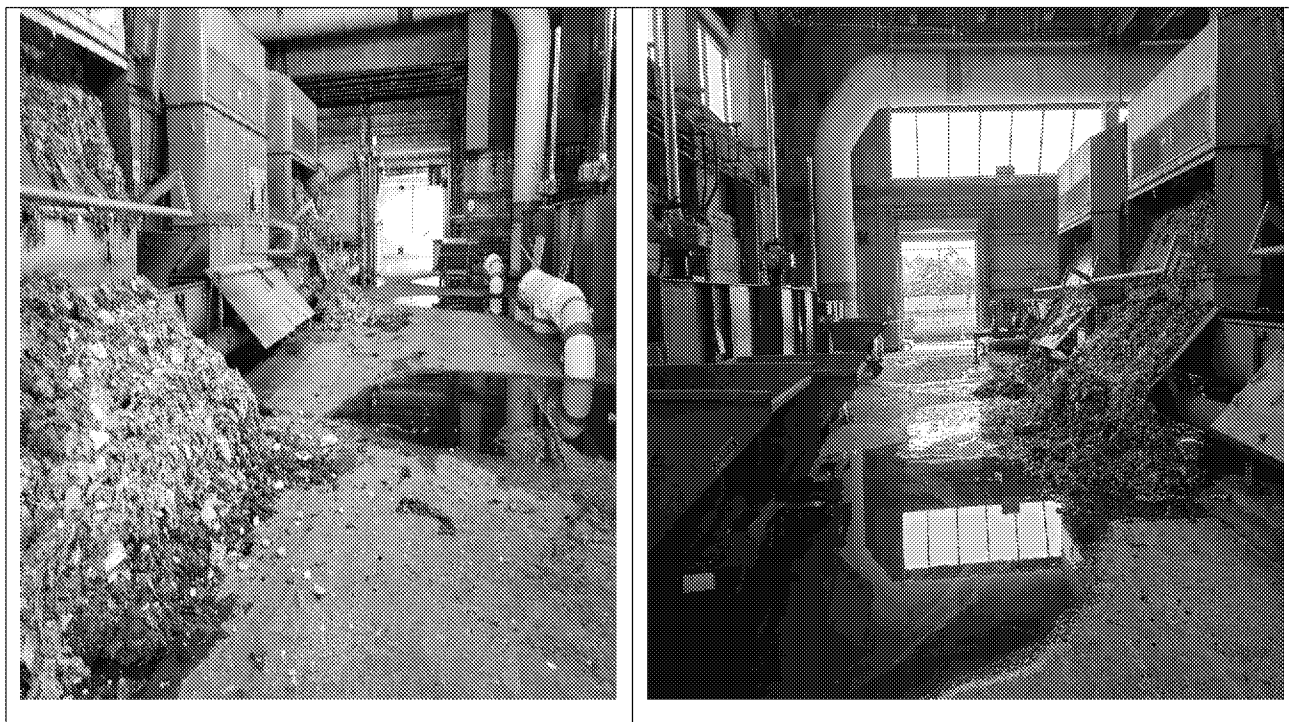
Figure 13 – Hyperion Headworks Barscreens with Excessive Trash and Debris

On July 11, 2021, Sunday, excessive amounts of trash and debris in the untreated wastewater collected on the barscreens at the Headworks Facility (Figure 13), resulting in flooding of Hyperion and untreated wastewater to overflow (Figure 14). This resulted in approximately 17 MG of untreated wastewater reaching the ocean through Hyperion's emergency 1-Mile Outfall. LASAN staff continue to investigate the source of this debris.

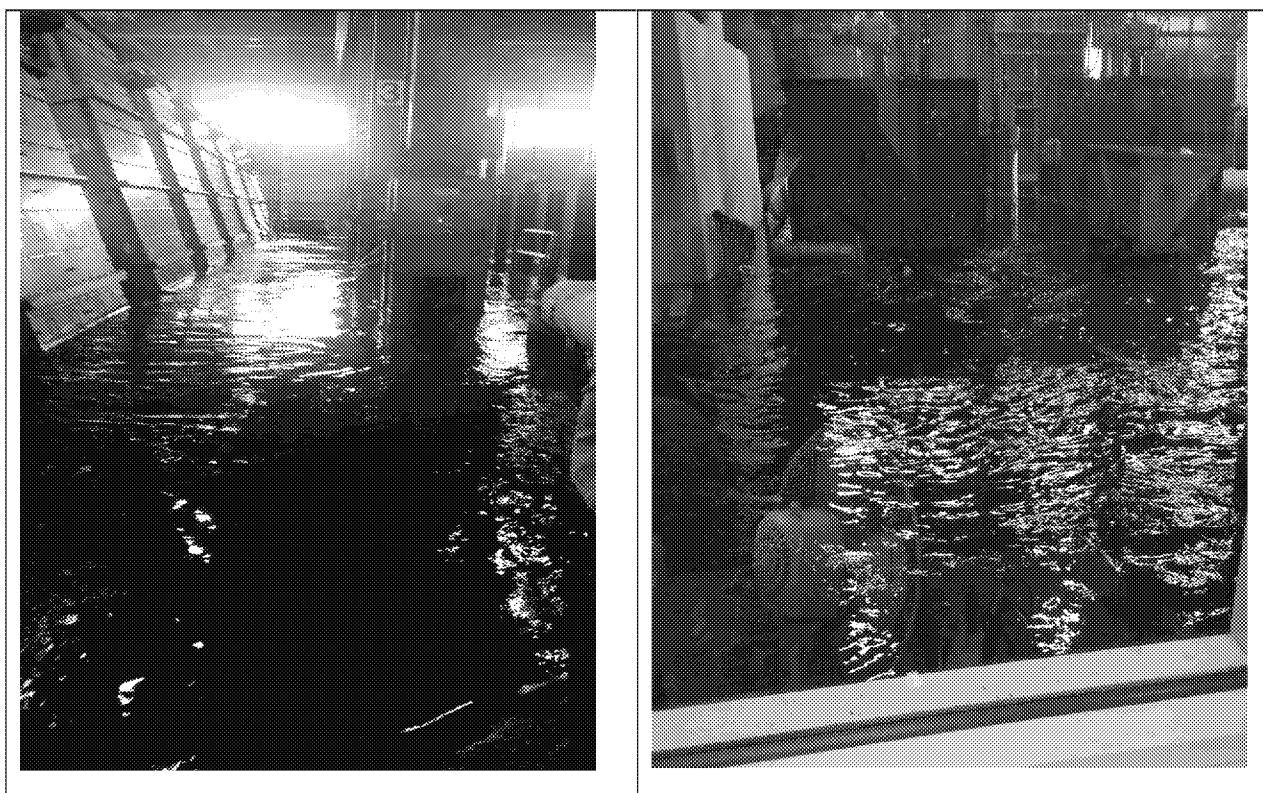
Figure 14 – Flooding at Hyperion Headworks

Around 1:00 PM on July 11, 2021, the Headwork Facility began experiencing problems. Headworks water level upstream of the barscreen was rising based on the Distributed Control System's (DCS) historical data and trend line. The unusual rise in the water level may be an indication of plugging of the barscreens as debris accumulates, obstructing the flow of untreated wastewater through the barscreen and into the treatment process. It should be noted that on the 5-Day Report to RWQCB and USEPA, it was first reported that the Headworks Facility began experiencing problems around noon and the operators first noticed Headworks water level upstream of the barscreens was rising. However, after further investigation, it was concluded that the Headworks Facility began experiencing problems around 1:00 PM.

It should be noted that on 5-Day Report to RWQCB and USEPA, by 3:00 PM, the Headworks facility was overwhelmed and some untreated wastewater began to overflow out of the Headworks building and into the streets within Hyperion, flooding the plant. However, the operators present during the incident stated that the sequence of events of when the problems started to the time untreated wastewater spilled out of the headworks happened very fast and nobody (operators present during the incident) seemed to know what time anything happened. However, based on when the Work Request was submitted at 3:13 PM, the WTO II noticed untreated wastewater coming out of the maintenance hole on the South East driveway of the Headworks Facility as he was approaching to assist at Headworks (estimated 3:30 PM).

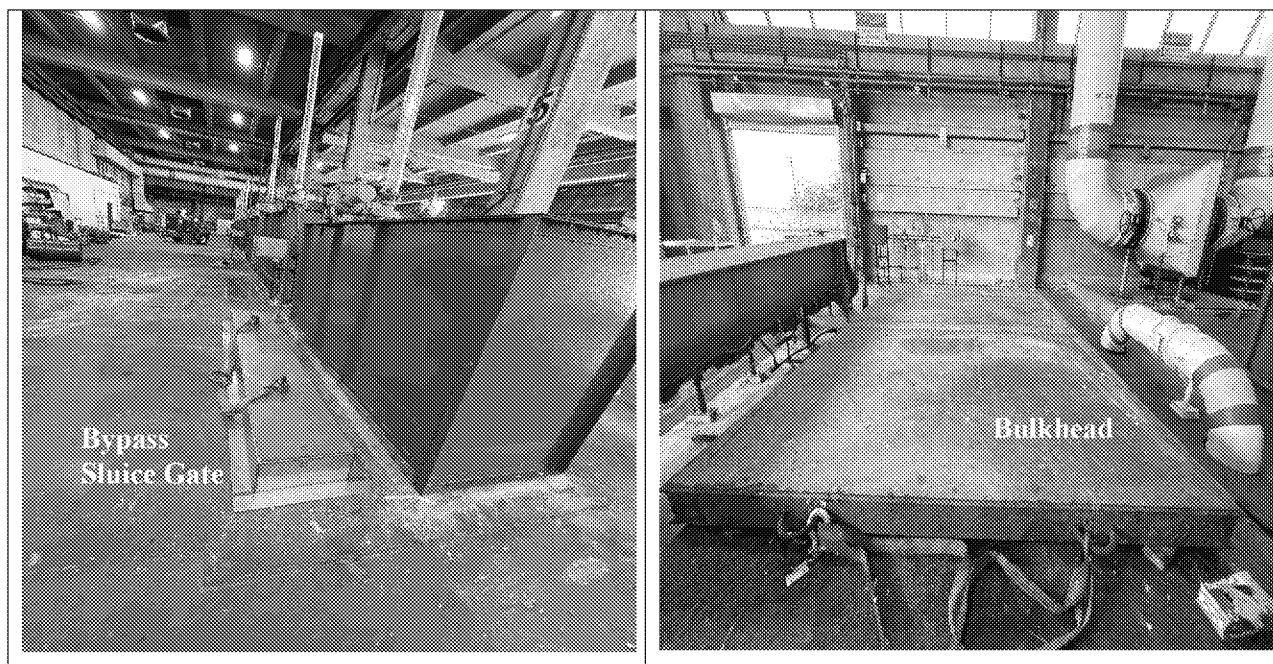
Figure 15 –Bypass Sluice Gate (Left) and Bulkhead (Right)

After all efforts were exhausted in getting the barscreens online, the operators attempted to open the headworks emergency bypass gate around 4:30 PM to allow incoming untreated wastewater to bypass the plugged barscreens. However, they had difficulty to remove the bulkhead upstream of the bypass sluice gate (Figure 15) possibly due to accumulation of trash and other debris preventing its removal. Operators were walking around using push brooms and squeegees to make sure they were not going to fall in any open holes.

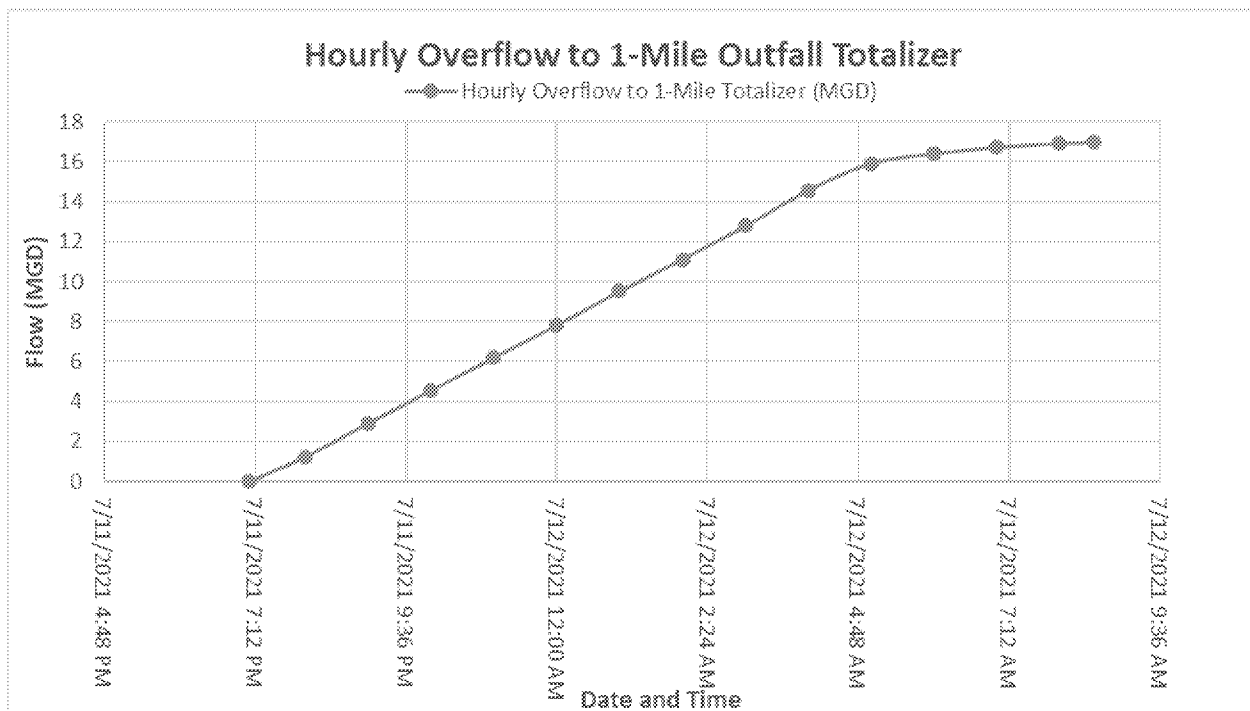
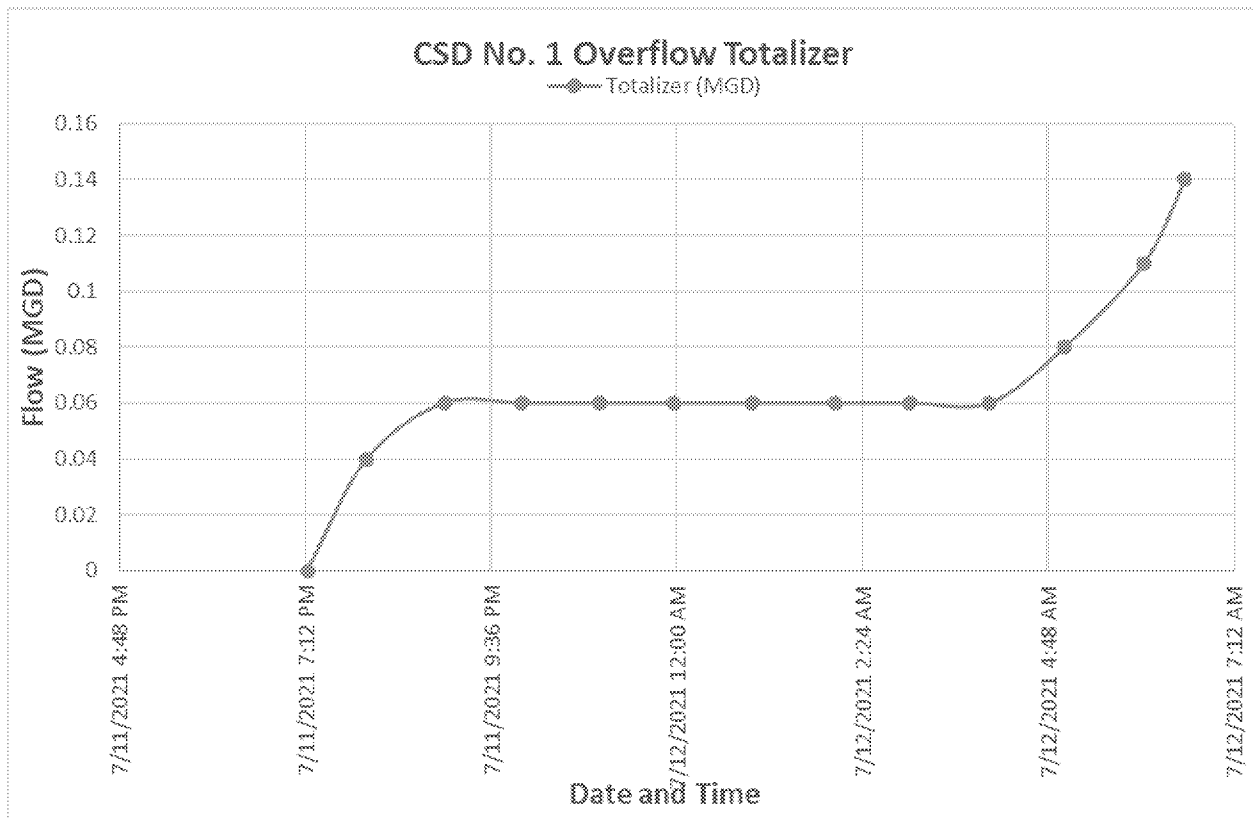
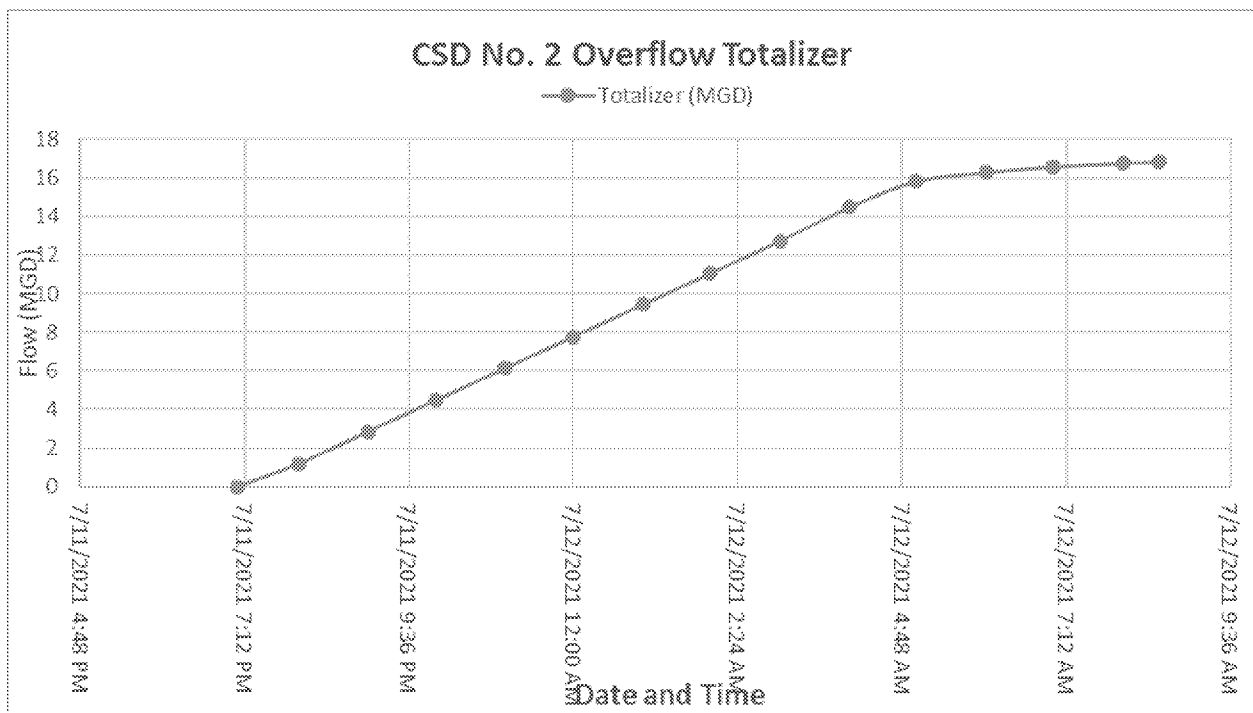
Figures 18, 19, and 20 show that up to 16.874 MGD of untreated wastewater flowed into the ocean with approximately 0.134 MGD and 16.74 MGD, respectively, from CSD Nos 1 and 2; and 0.08 MGD into the 5-Mile Outfall. There were no trash or solid debris discharged into the ocean due to screens at the entrance of catch basins throughout the plant.

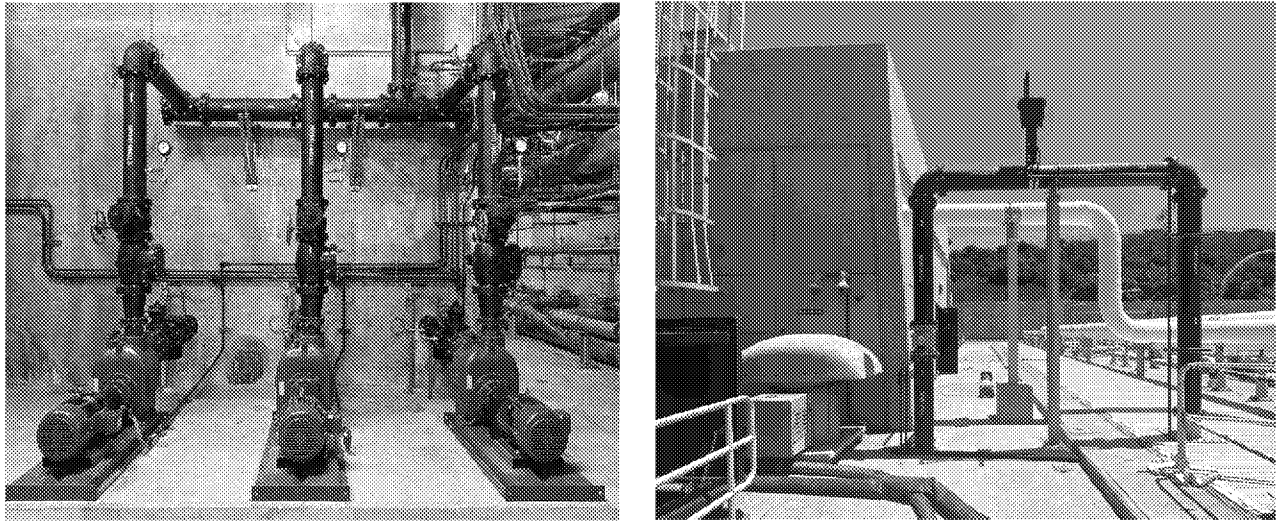
Figure 23 – CSD No. 4 Pump Room (Left) and Effluent Piping to PBD (Right)

The 2017 Central Storm Drain Rerouting Project converted the existing sludge wet well to collect and transfer stormwater from North of 7th street to the primary influent channel. This project was completed in September 2020. The resulting drainage area for this project was about 14 acres. This project reduced the drainage area of CSD No. 2 by 30%. During the spill, 270,000 gallons was collected and pumped to PBD. Unfortunately, the pump room flooded and stopped the pumps. More of the water would have been collected and pumped to PBD. Figure 23 show the CSD No. 4 pumps and piping to PBD.

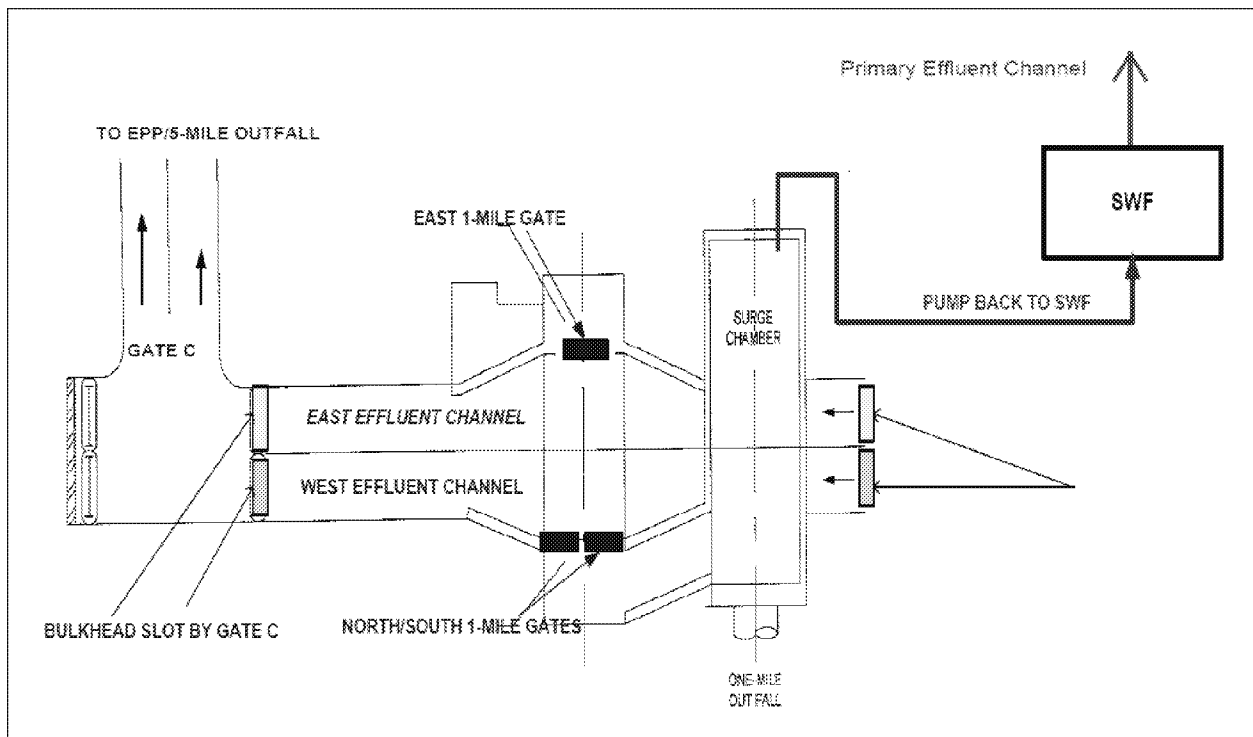
Figure 24 – Diagram of 1-Mile Surge Chamber Pump-Down to Service Water Facility

The plant installed a temporary pump-down system to pump untreated wastewater in the 1-Mile Outfall Surge Chamber back into the SWF Backwash Wet Well, diverted and pumped to the Primary Effluent Channel where the untreated wastewater resumed secondary treatment.

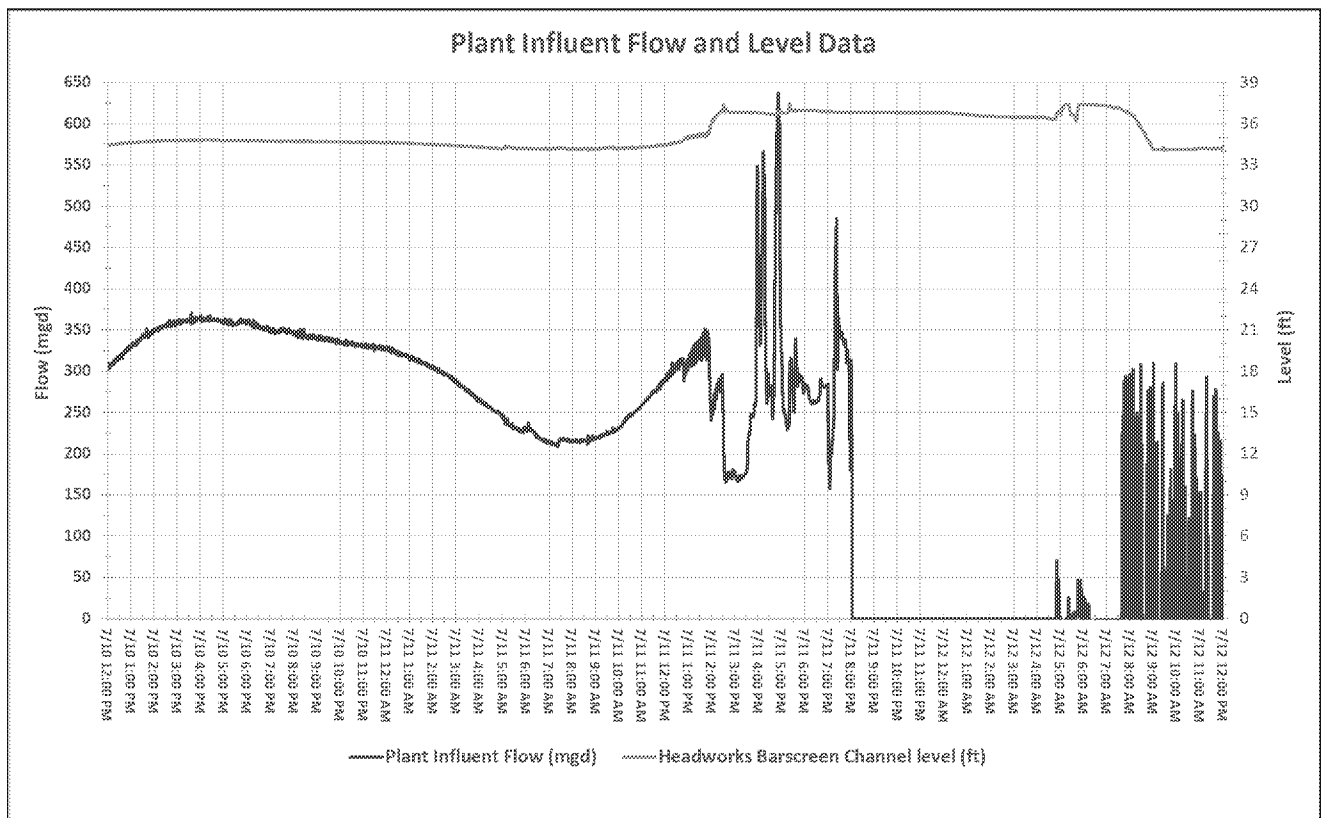
Figure 28 – Hyperion Influent Flow and Level Data Graph

Figure 28 shows the Headworks Barscreen Channel Level and Plant Influent Flow during the spill incident on July 11, 2021. From the graph, the barscreen channel level started to increase around 1:00 PM. On July 12, 2021, around 4:30 AM, the bypass emergency channel gate was opened and level in influent channel dropped significantly as shown in the graph.

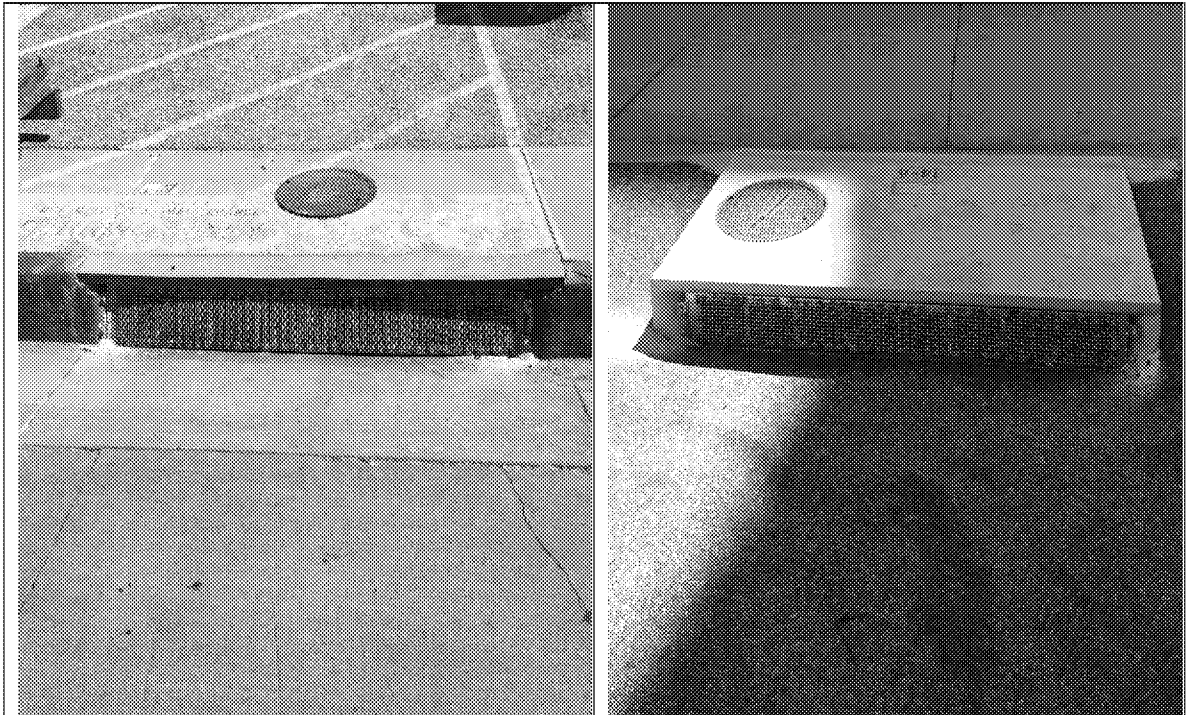
Figure 29 – Storm Drain System & Catch Basins

- Installation of screens on all catch basins in the plant which was completed in 2015 (Refer to Figure 29)

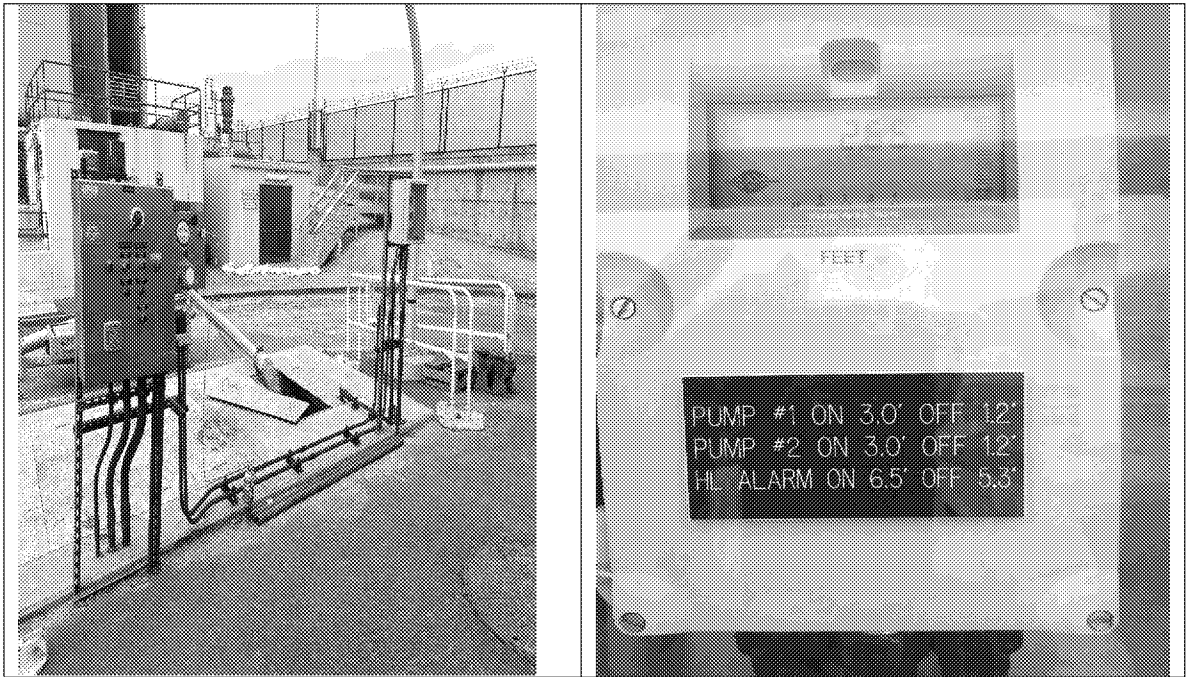
Figure 30 – CSD No. 2 (Left) and Level Sensor (Right)

- New Storm Drain monitoring sensors and level indicator was installed in 2015. (Refer to Figure 30)

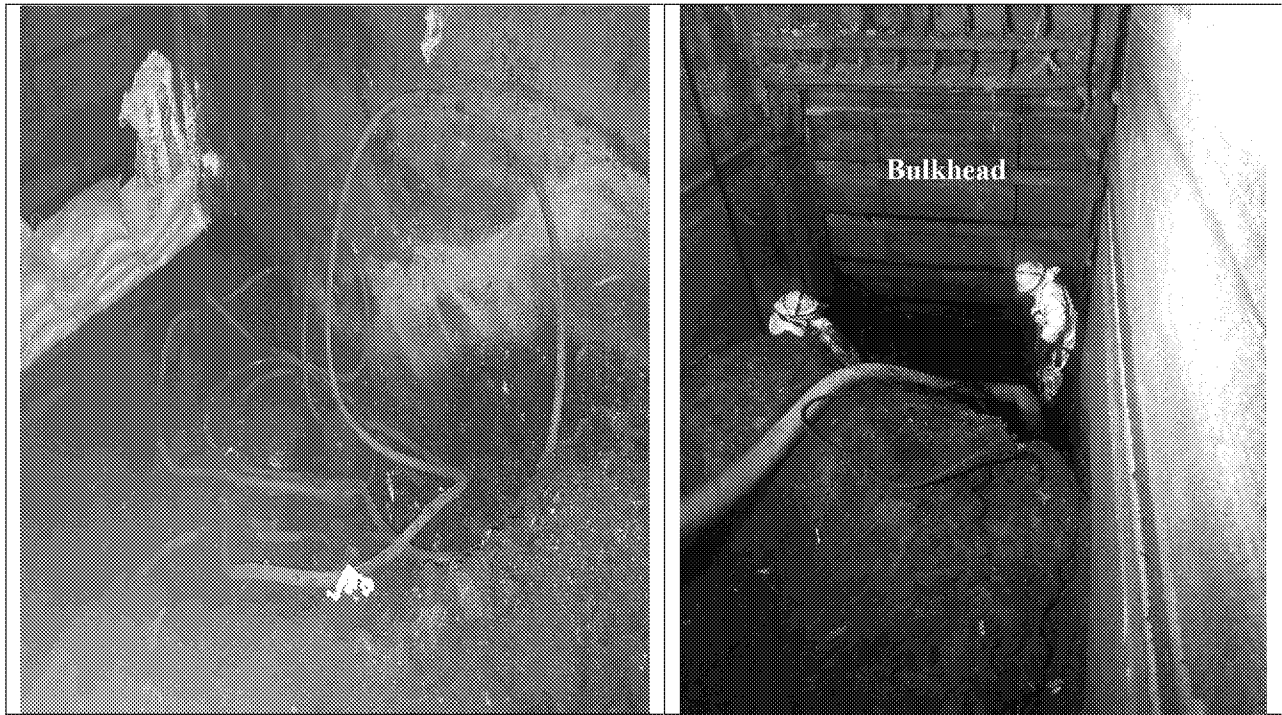
Figure 32 – Headworks Barscreen Bypass Channel

- Headworks Bypass Channel Project was completed in May 2019. (Refer to Figure 32)

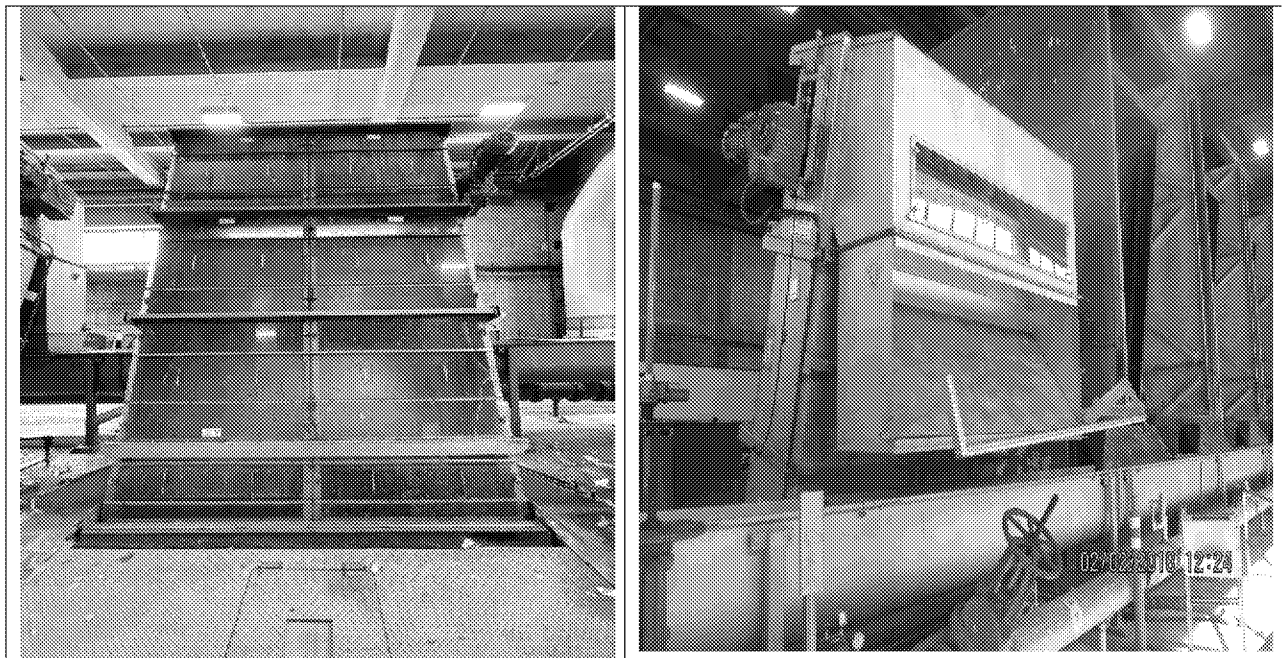
Figure 33 – Headworks Barscreen

- Headworks Barscreens Improvement Project was completed in June 2019. (Refer to Figure 33)

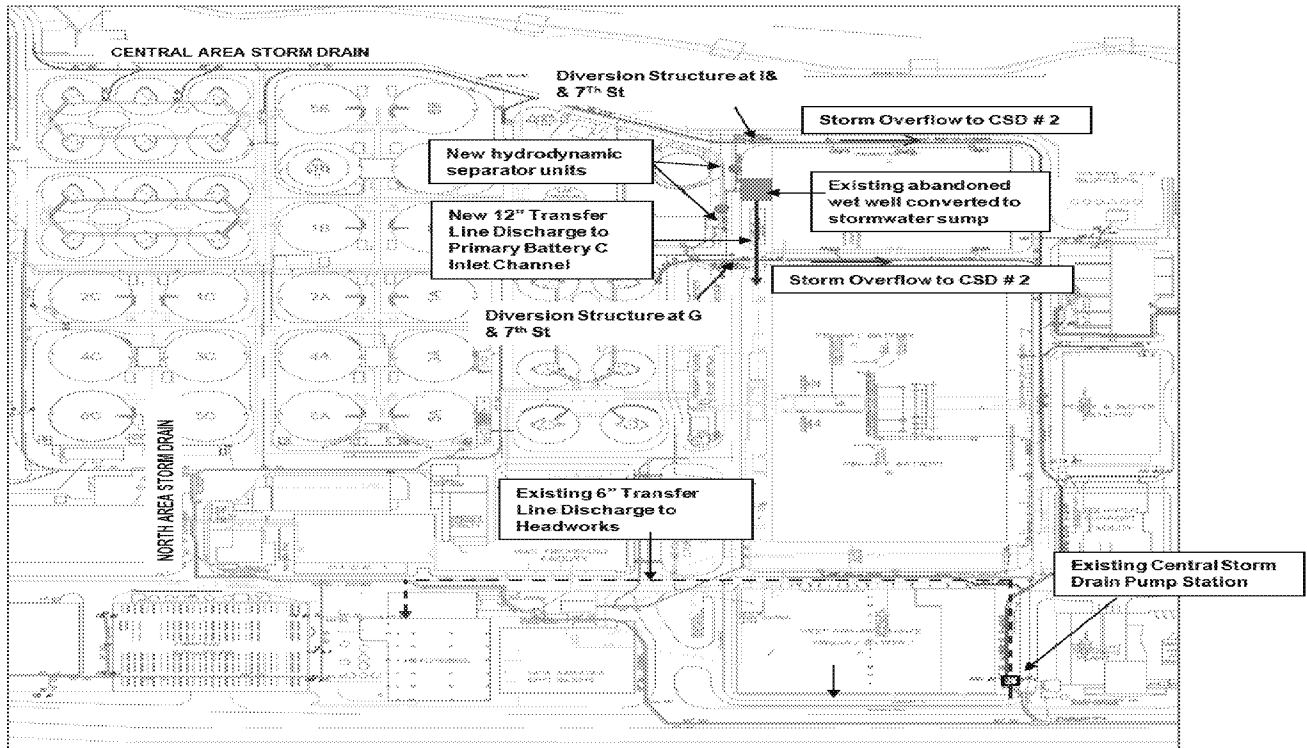
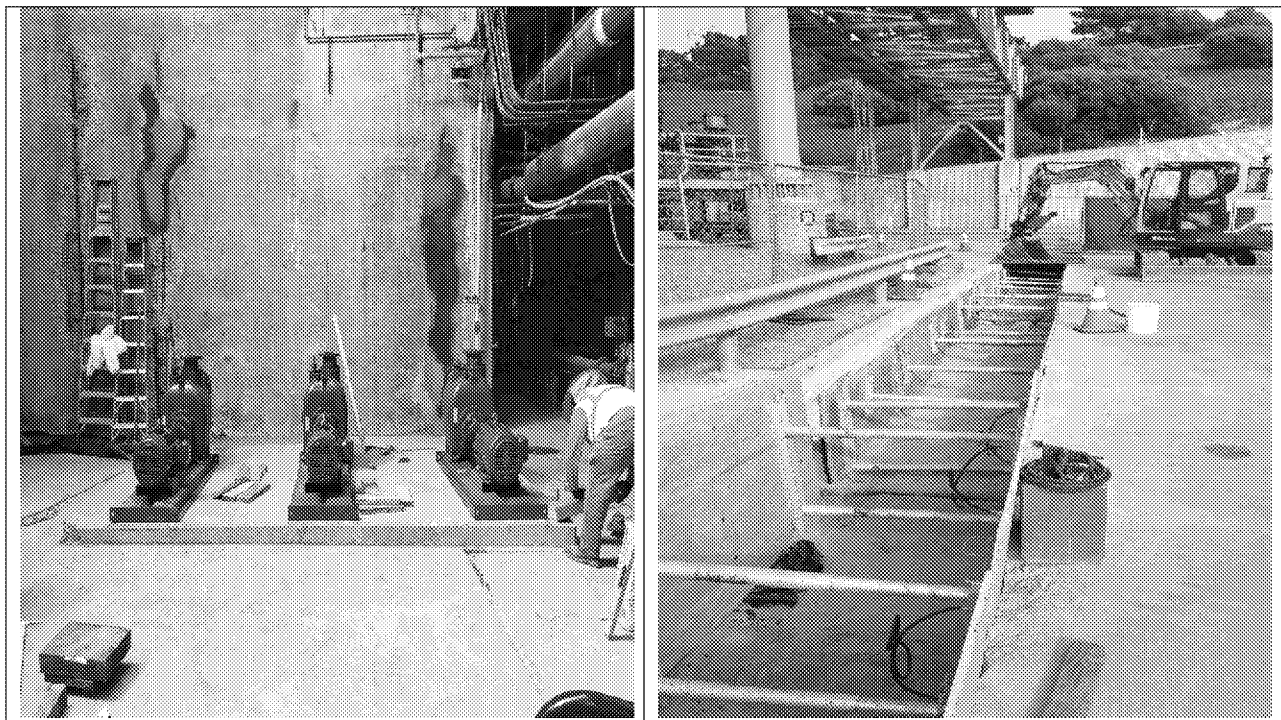
- Central Storm Drain Rerouting Project was completed in November 2020. (Refers to Figures 34 and 35)
